**The Journal of the  
Hillsboro Historical Society**

**Vol. 19 No. 2**

**May 2026**

**The Black Range Museum  
A Tale of Daring, Imagination — and a Lot of Hard Work**

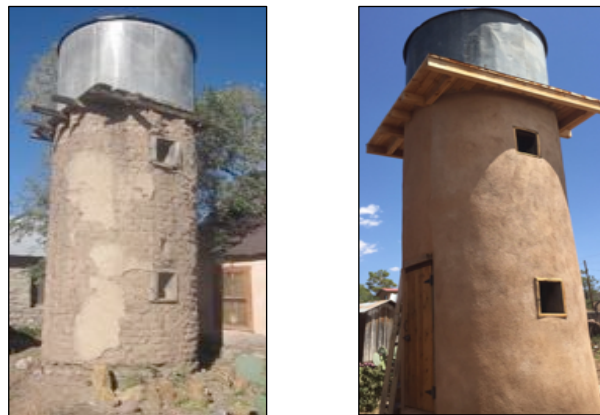
Figs. 4 and 5: Water tower before and after repairs

Behind the museum is a unique 25-foot-tall round adobe water tower. As seen in the left photo below taken in 2017, this remarkable structure was in terrible condition with rotting wood and eroding adobe. We felt it was in danger of falling on the building. Our highest priority for restoration, therefore, was this unique tower. Rand Berger and Bruce Cosper took on the task, removing the metal tank and rebuilding the wooden platform, followed by strengthening, repairing, and plastering the adobe exterior. The metal tank was then put back on top, and a door and screens for the small window openings were installed (Figs. 4 and 5). This effort was completed in May of 2018.

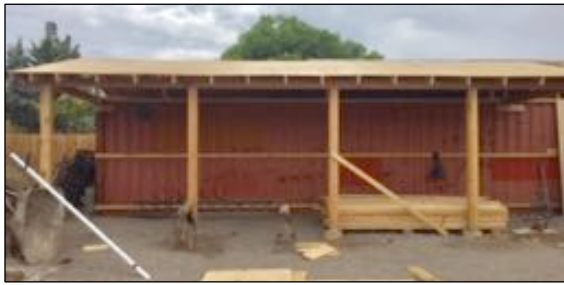
Fig. 6: The metal storage container under its new shed

It didn't take long to decide that a metal container unprotected from the sun is not a good place to store historic materials. The HHS hired Bruce Cosper to build a wooden structure over the storage container, with the roof extended on the yard side to provide a covered area for outdoor exhibits (Fig. 6).

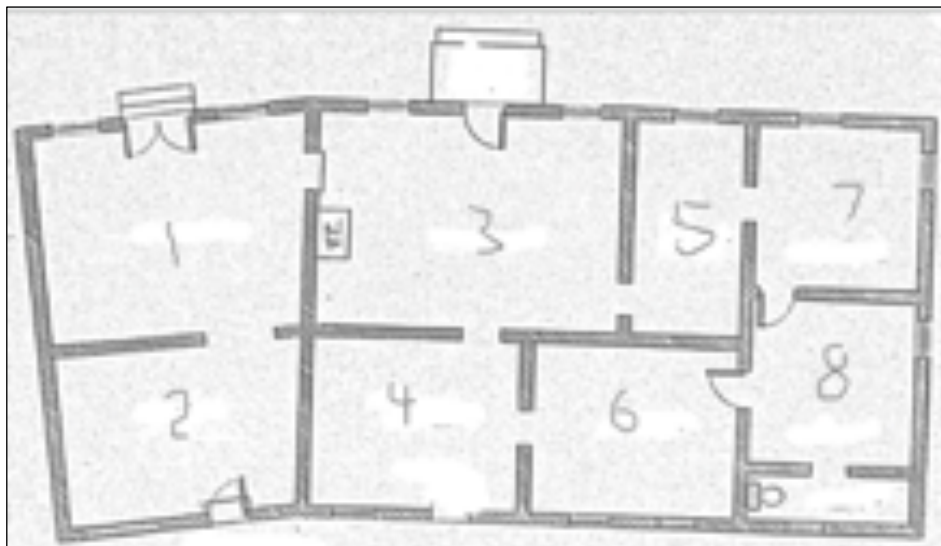
Fig. 7: BRM floor plan showing the eight rooms

A floor plan of the building (Fig. 7) prepared for HHS in 2016 shows the eight rooms numbered. It is readily apparent in this plan that Rooms 3-8 form a perfect rectangle while the two rooms on the west (1 and 2) are non-squared and represent a later addition. Moreover, the front of the west section is aligned with Main Street as laid out in the first town plat drawn in 1884. The east section, on the other hand, lines up along Carro Lane. We must assume that the eastern section was older and that the western section was an add-on.

Constructing the higher roof of the west section proved to be quite a challenge. The trapezoidal shape of Rooms 1 and 2 (see again Fig. 7) results from the fact that the front of this section is fully six feet wider than the back. Bruce Cosper's solution to the problem was to square the north pitch and to stagger the south pitch, as seen in the photo to the right (Fig. 23).

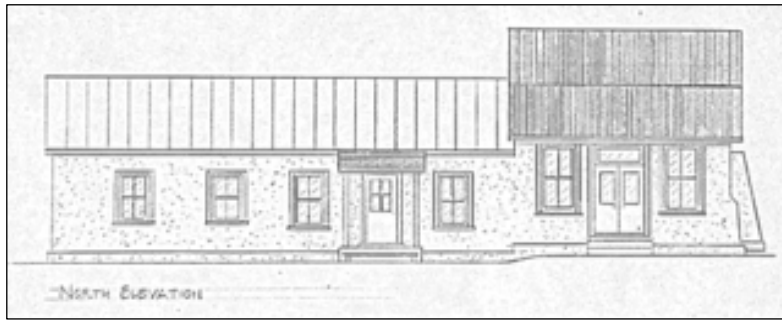
Fig. 10: Elevation of north side of BRM in 2017

The architectural drawings whipped out for us in 2017 included sketches from each side of the building. The depiction from the north (Fig. 10) shows the building essentially unchanged from its structure in the photo of Sadie's hotel more than a hundred years earlier. Both show that the west portion is considerably taller than the eastern section. In addition, both depictions capture the fact that the west roof consists of two parts.

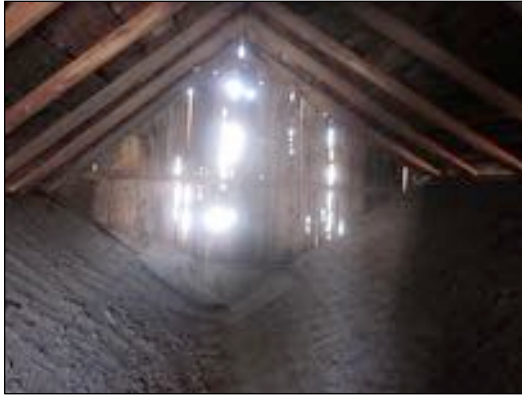
Fig. 11: Inside the attic over the BRM west section, 2017

Climbing onto the roof of the east part to enter the attic of the west part, I took a photo from just inside facing west (Fig. 11). Beneath an overarching higher roof, Rooms 1 and 2 each had its own pitched roof of wood shingles. The result of this strange construction was to create a trough in the middle, which would in effect dump half of any precipitation to the east and west sides – most significantly onto the lower roof of the east section! To correct this flaw, the higher overarching roof had been added even before the photo in Fig. 9 was taken.

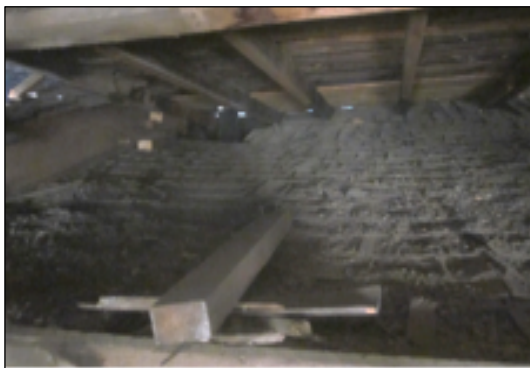
Fig. 13: In the attic of the east section looking north

First, Fig. 13 reveals that only the north half of the east section originally sported a pitched roof. And it too had wood shingles, not easily discerned under decades of dirt, dust, and grime. The newer long metal roof had been extended from that earlier peak all the way to the south side, accounting for the imbalance seen in the east elevation drawing.

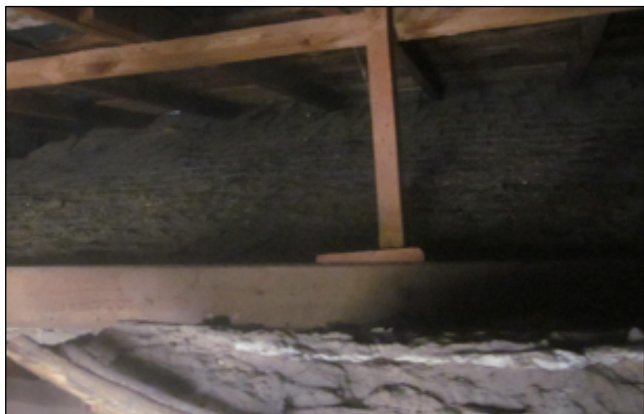
Fig. 14: Attic above Rooms 4 and 6 with latillas and mud forming original roof

Second, above the false ceilings in Rooms 4 and 6 there was another ceiling composed of pine vigas and sotol latillas (Fig. 14). The photo in Fig. 13 was taken facing east after the false ceilings were taken down. The latillas were covered with 8 to 10 inches of mud treated on the top to shed water. Indisputably, the original roof for these two rooms was almost flat and sloped to the south. Most concerning, we see the bending latillas under the weight of the mud. In fact, about a third of the latillas in Room 4 had already collapsed. This dangerous situation was one reason we could not open these two rooms to the public.

In June of 2017 Steve Dobrott and I began the task of removing that original ceiling/roof, pulling off the mud chunk by chunk and taking down the latillas one by one as we freed them from their burden. It was a dirty, dusty, exhausting job. We hauled wheelbarrow after wheelbarrow of mud out the back door, dumping it along the extended foundation in yet another attempt to keep water away from those south walls. The photo below right illustrates how much mud was hauled out (Fig. 16). In the left photo we see Steve, masked way before COVID-19, at the last stage of clearing out the rooms (Fig. 15).

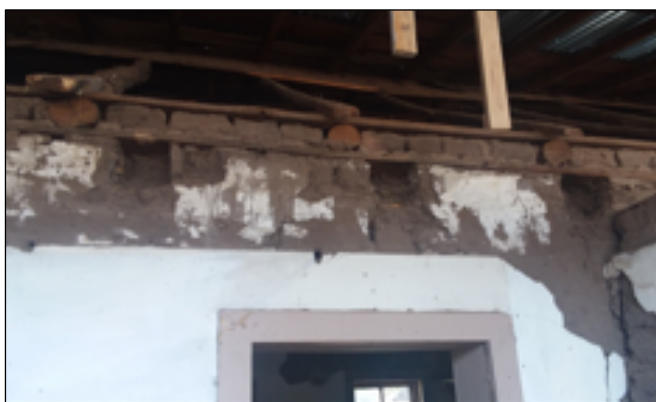
Fig. 17: North wall of Room 4, supporting the original roof

To understand the original structure of this part of the building, it may be useful to consider Fig. 17 taken a year later of the north wall of this same Room 4. Through the doorway is Room 3, Ying's kitchen. Just above the doorway we see the level line of the plaster under the false ceiling. Above this are traces of old plaster that would have once reached up to the level of the latillas. The three big holes in the wall are where the pine vigas have been removed. Above these holes between the two layers of boards we see, not just stabilizing adobes, but the ends of three vigas that provided the original ceiling for Ying's kitchen; these vigas are of alder trunks, much smaller than the pine vigas. Finally, above the top board we see the trimmed ends of three rafters that supported the original pitched roof.

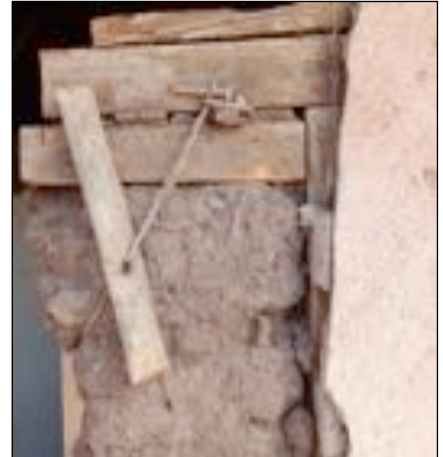
Fig. 18: The winding board tightening the joining of two walls

Another indication of the later construction of Rooms 4 and 6 can be appreciated in the photo at right (Fig. 18). When we removed most of the collapsing exterior wall, an odd device was revealed. A strong piece of wire had been tied around the added wall to bind it to what had been the original wall of Room 8, and a winding board had been used to tighten the joining of the two walls. Though not shown in this photo, there was again no interlacing of the adobes of the two walls, so the binding wire had been necessary.

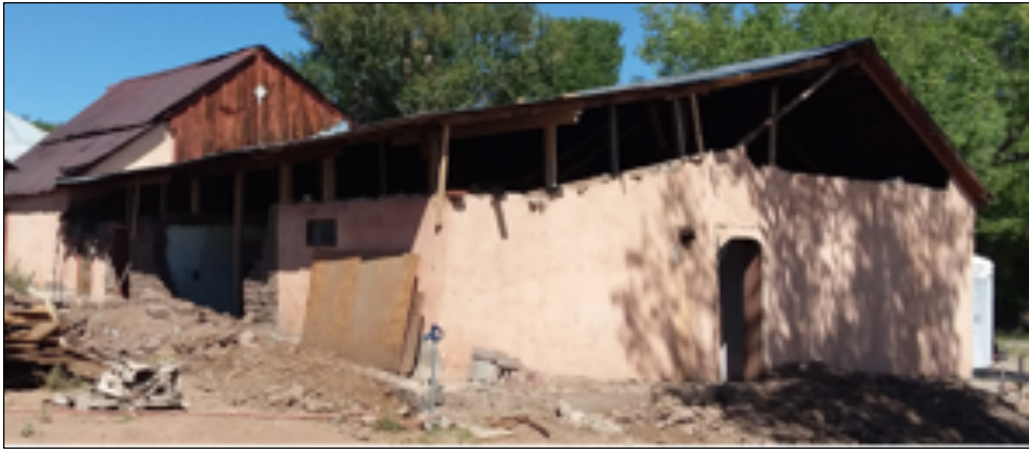
Fig. 19: Literally raising the roof on the east section

The next step was to disconnect and raise by several feet the entire east section's roof (see Fig. 19). This was necessary in order to work unimpeded during the monsoon season on stabilizing the building's walls. Notice the still intact parts of the east portion. And on the still covered west section you can see, just below and to the left of the Eastern Star, the attic access I entered to photograph the design flaw there. Notice too the additional mud removed through the newly uncovered east door.

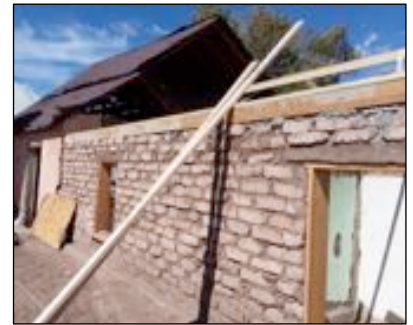
Fig. 20: Rebuilt adobe walls

With the old roof raised and securely anchored, the collapsing exterior walls of Rooms 4 and 6 were taken out, and those walls were rebuilt with new adobes on top of the cemented rock wall, as seen in the photo to the right (Fig. 20). Openings were built for one window in each room. The photo also shows the cement bond beam set at the top of the wall as would be done for all other walls. The false and original ceilings in all six rooms were removed. The vigas and latillas from Rooms 4 and 6 were placed far out in the back yard for future use.

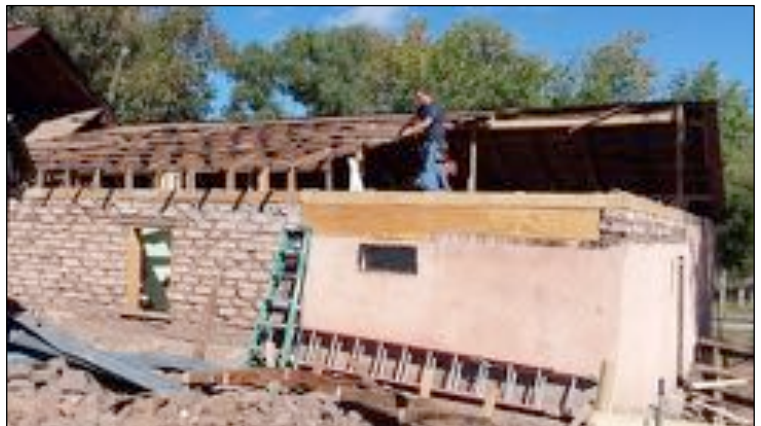
Fig. 21: Asa Cosper removing the old east section roof

Once these solid under-pinnings were in place, the old roof of the east six rooms – along with all ceilings, rafters, and vigas – was removed. In Fig. 21, we see Asa Cosper beginning the roof removal in October of 2018. A brand-new supporting structure of beams and rafters was then constructed over the now-stabilized walls.
